DEMOLITION REPORT BCF OIL SITE 360-362 MASPETH AVE BROOKLYN, NEW YORK

Prepared by
Comprehensive Environmental Utility Services, LLC
For
New York State Department of Environmental Conservation

January 26, 2008

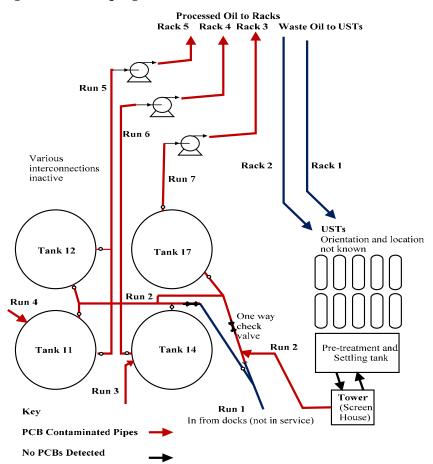
Figure 2 BCF Piping Schematic

- Piping runs were identified by recreating through observation and examination of piping diagrams the flow of materials through the former facility. A schematic piping diagram representing the piping configuration at the time the PCB oil entered the facility is provided as Figure 2 above.

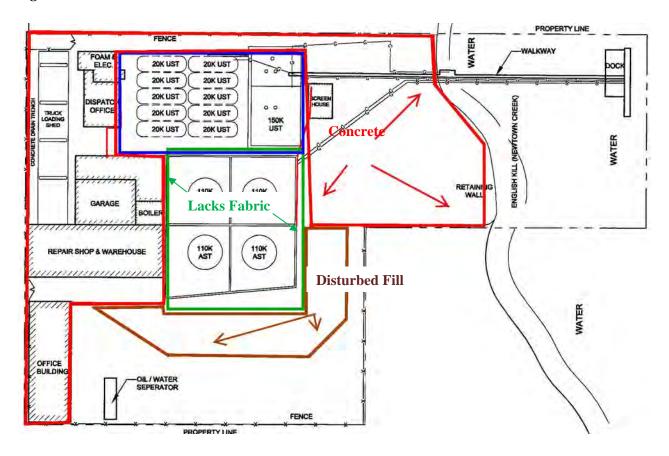
Figure 3 Disturbed Soil Location

A portion of the site contains a blue stone protective cover without an underlying geotextile fabric. The approximate area of blue stone lacking fabric is shown on Figure 3. In general, this is the area of the former ASTs. This discrepancy occurred due to a miscommunication of requirements to the contractor laying the blue stone.

Soil was exposed and disturbed in an area of the site as shown on Figure 4. This occurred between the time recycled concrete was removed and blue stone with fabric was placed. The result was to disturb the top surface of site soil and to transport some soil onto concrete located at the rear (southern) portion of the site. This discrepancy occurred due to a miscommunication of requirements to the contractor removing the recycled concrete.

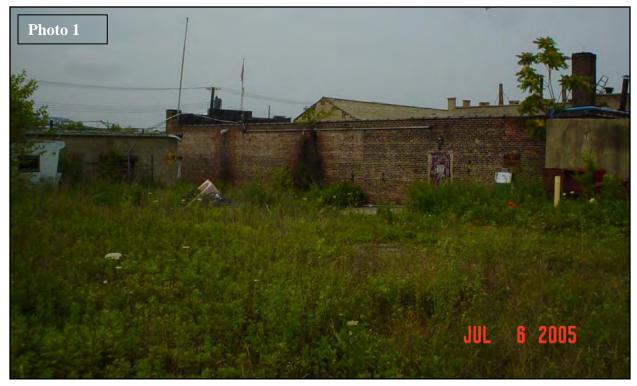
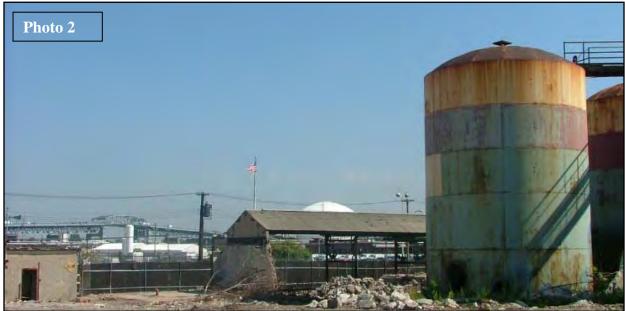
Looking north-east: Warehouse has been removed in lower photo leaving the office building to the left, the rack in the background and one of the AST shown to the right.

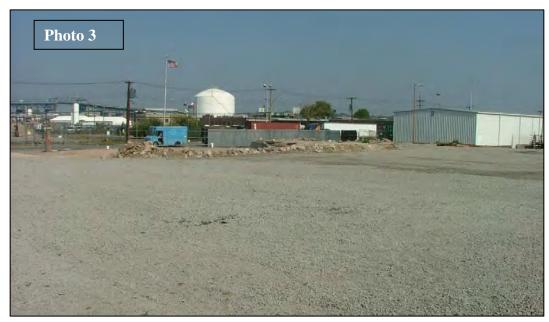
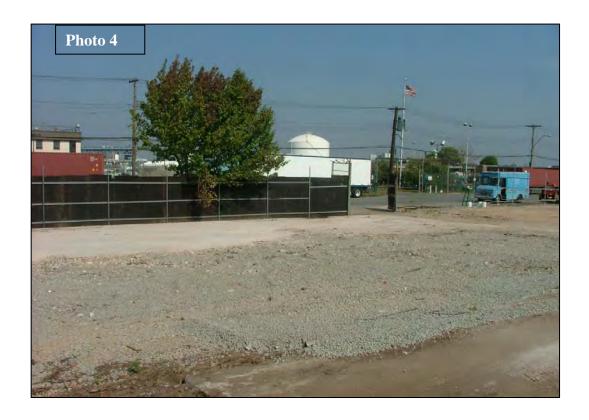
Office building and rack after final removal. Concrete pad of former oil water separator is in the foreground in photo below.

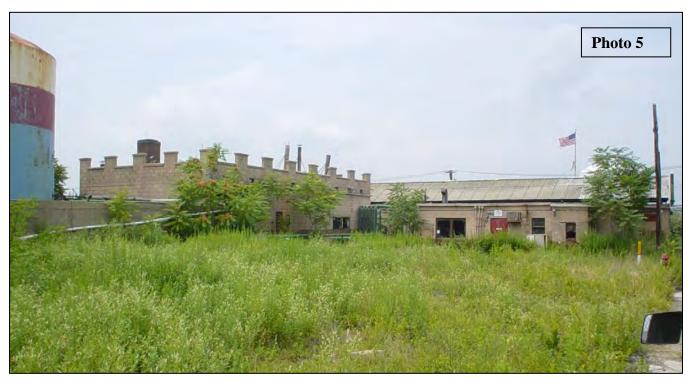
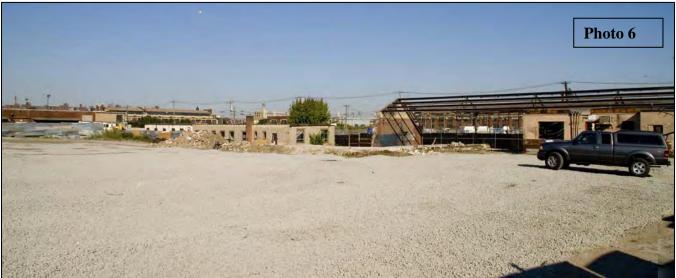
View looking north-west before and after demolition of ASTs and boiler room. Fire suppression building, rack and office building in the background have since been removed as is shown on the next page. The rack piping can be seen in the middle of the top photograph.

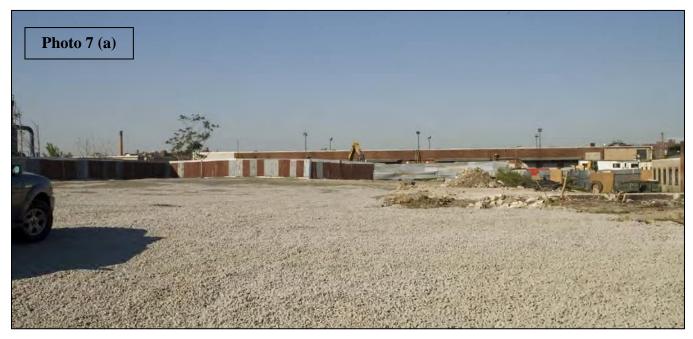
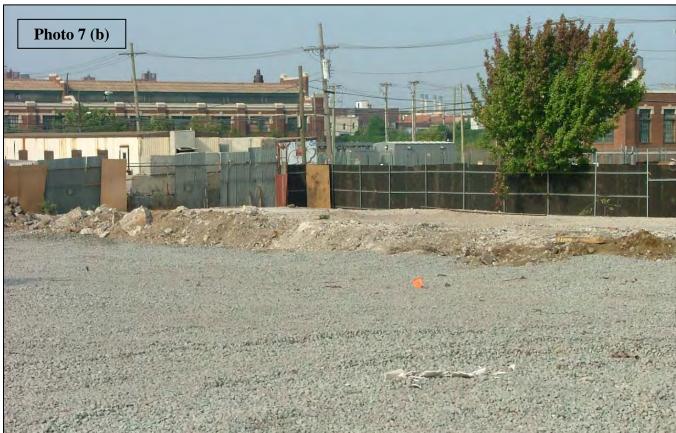
Completed building removal

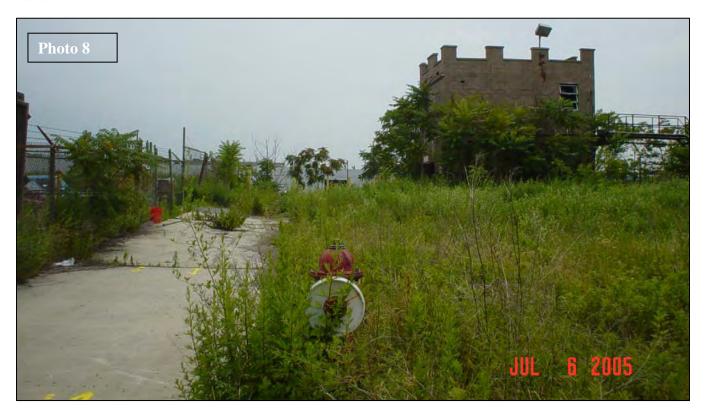
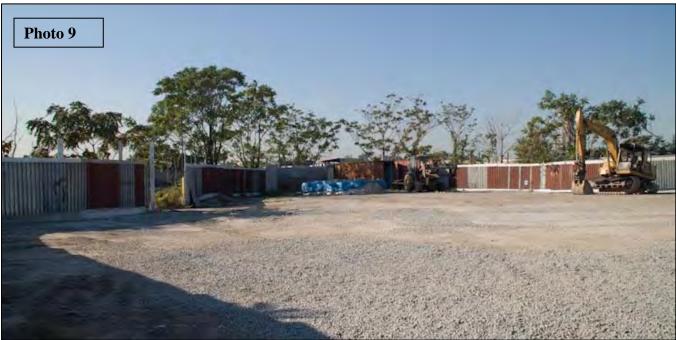
Looking south: Screening Tower in top photo has been removed. The lower photo looks through the area of the former screening tower toward the drum storage area situated on concrete.

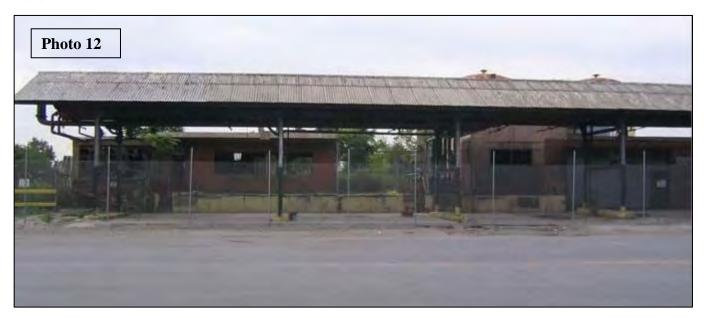
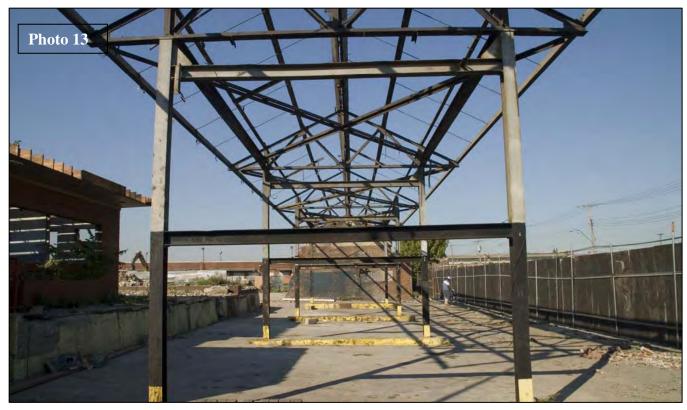
Loading/Unloading Rack: Lower picture is after piping and asbestos roof removal. Supporting steel structure has since been removed as well, as shown on the next page.

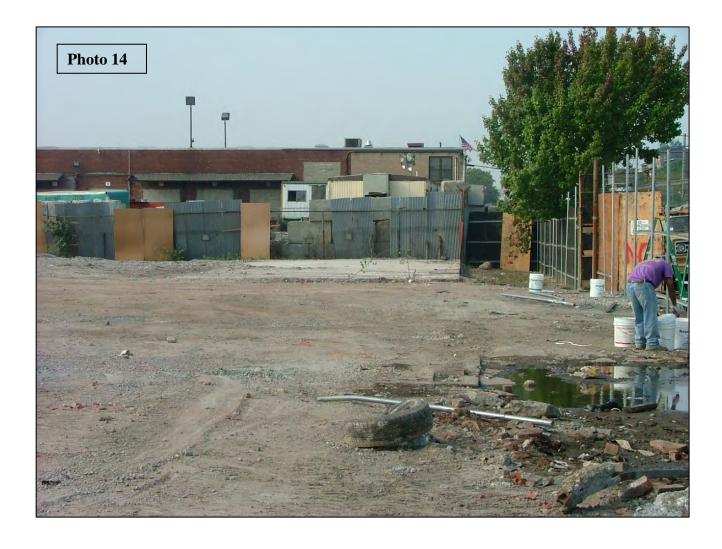
Same view as previous after rack and office building have been removed. Fence to right is being upgraded for future property use.

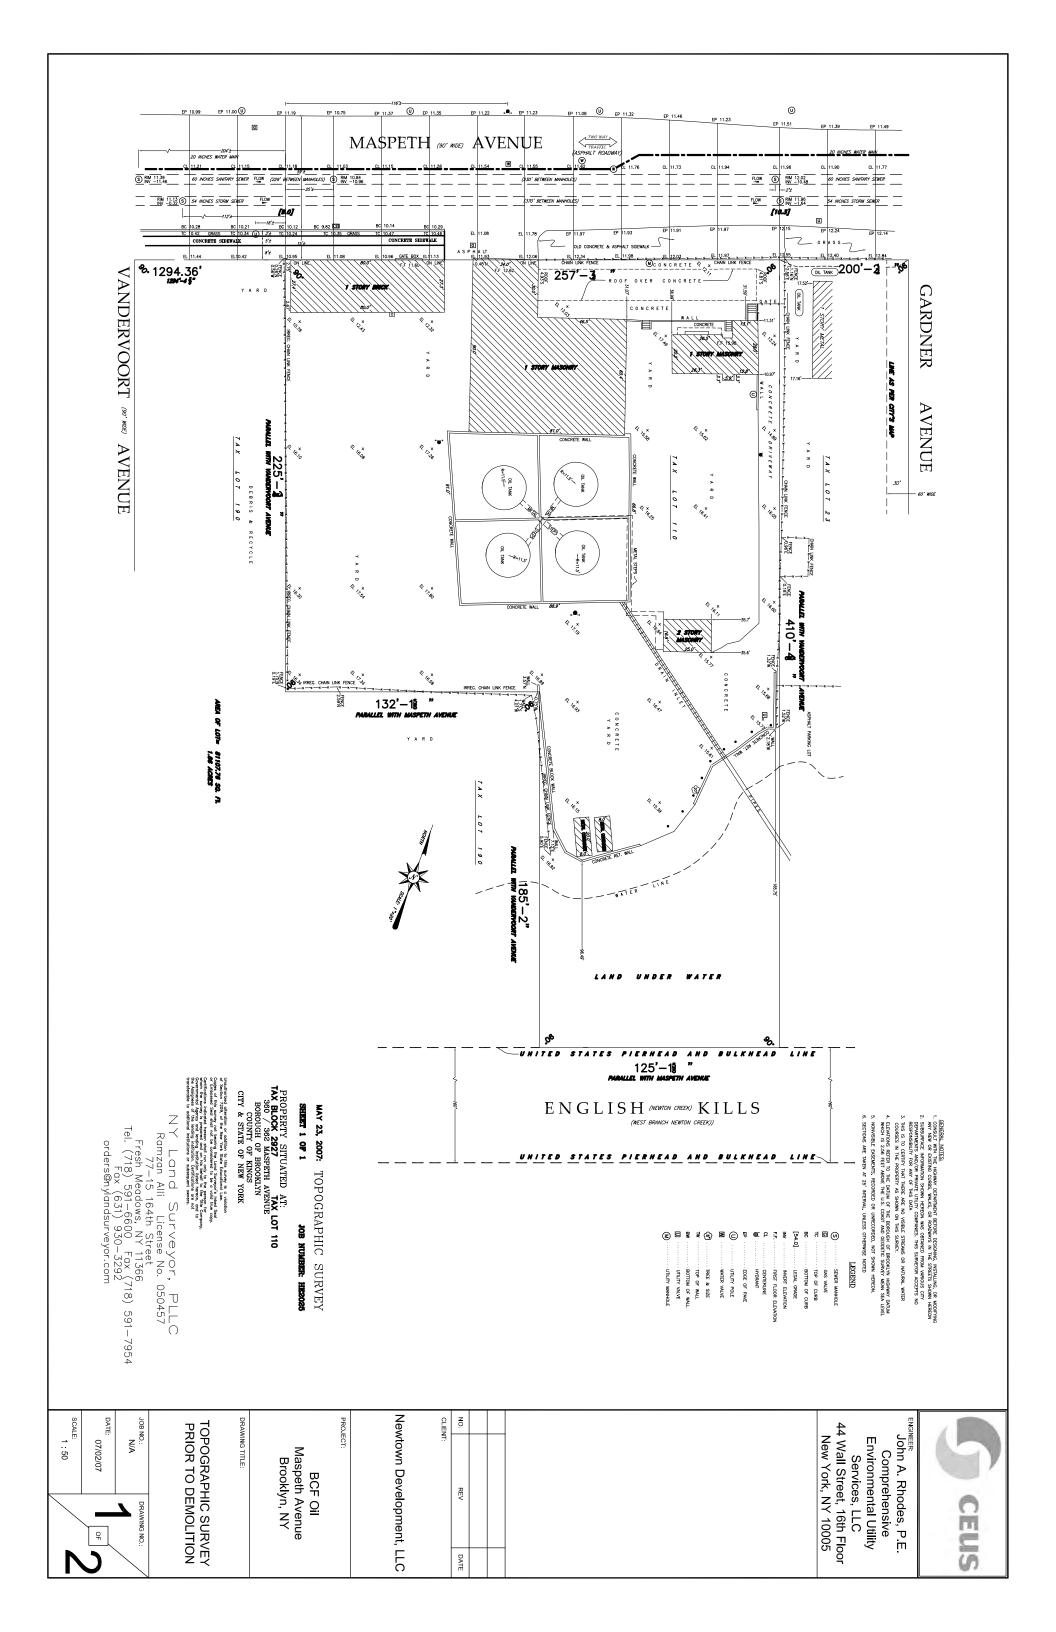
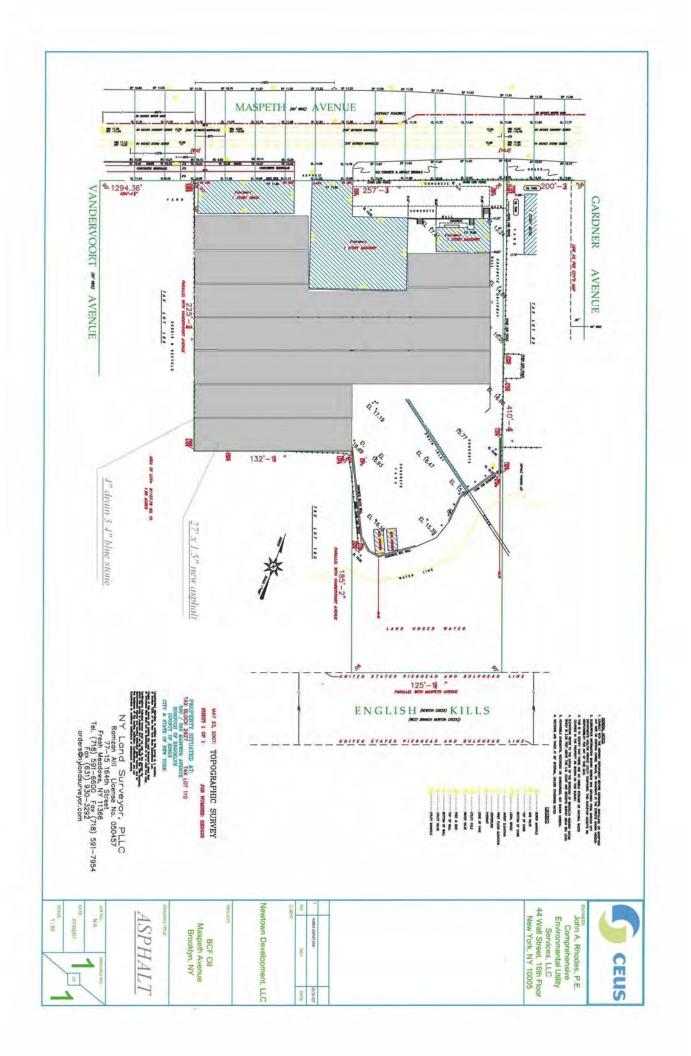
Appendix C Before and After Surveys

The topographic survey and photographs were taken to provide pre and post demolition images. The survey is in Appendix A and images are provided in Appendix B.
